LEVEL 1

Your survey report

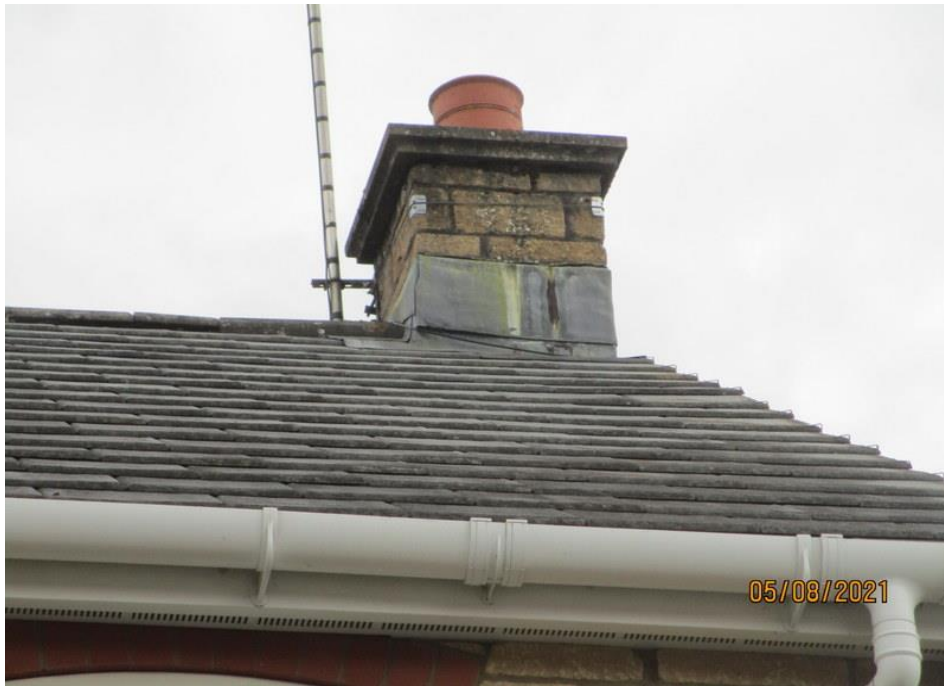
There is one chimney stack located to the right side of the property. It is of concrete block construction. Condition rating 1.

The chimney is in satisfactory condition at present with no urgent repairs required.

The roof coverings consist of artificial slate with a traditional bitumen underfelt beneath. Condition rating 2.

The roof coverings are in adequate condition however they will require maintenance over time.

This should include repointing or re-bedding of ridge tiles at the top of the roof and repointing of the exposed verge to the right side edge of the roof. Some deterioration of the mortar pointing was noted in these areas.

Chimney and roof coverings viewed from the front showing also plastic rainwater fittings.

In time it will be necessary to carry out general maintenance including repointing of the masonry, repair or replacement of flashings and attention to detailing around the top of the chimney.

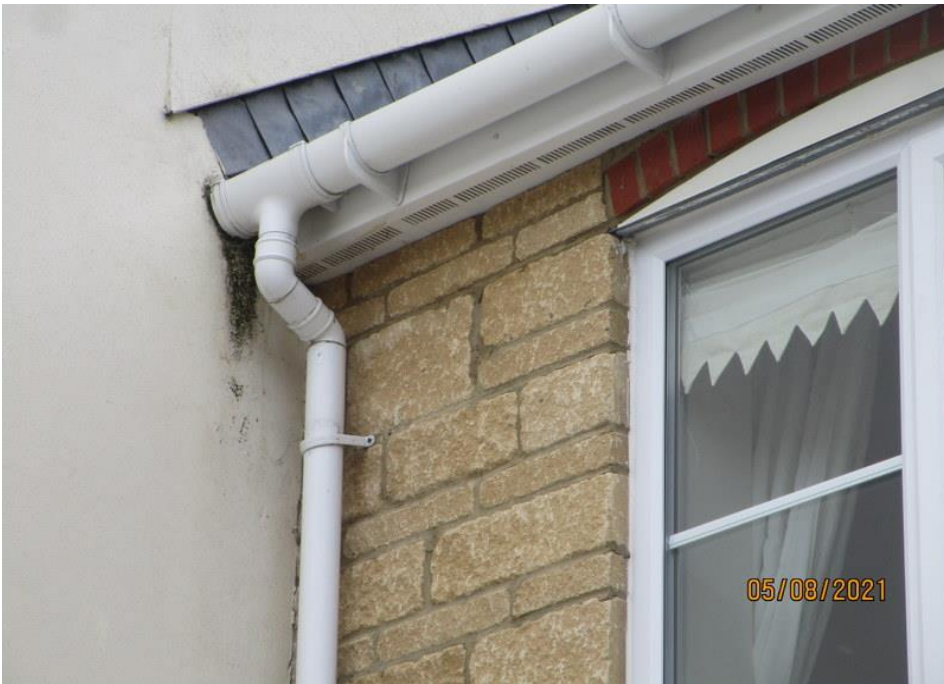
Signs of possible blockage and overspill were noted to the gutters to the right rear with staining affecting the wall of the neighbouring house.

Signs of overspill around the downpipe to the right rear of the property.

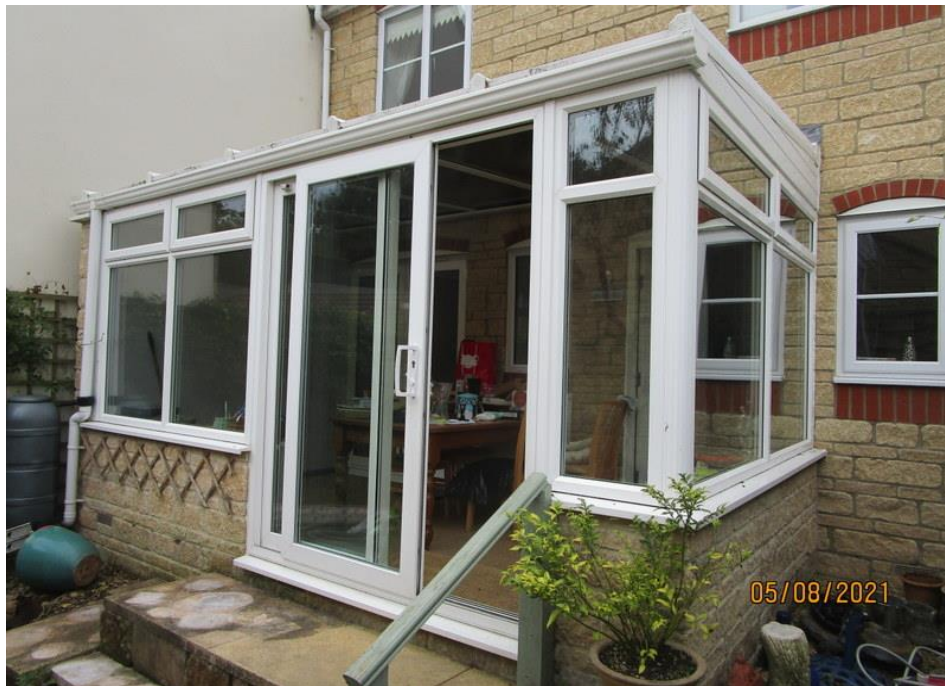
There is a conservatory extension to the rear. It consists of small masonry walls, double-glazed PVC windows and doors and plastic sheet roof coverings. Condition rating 1.
The conservatory is in adequate condition although it will be hot in the summer and cold in the winter.
Conservatories tend to have a limited life expectancy and you should plan for replacement in the medium or long term with a proper extension.
As a short-term measure, you could consider fitment of an insulated roof however this will reduce levels of natural light in the kitchen and sitting room.

Conservatory extension.

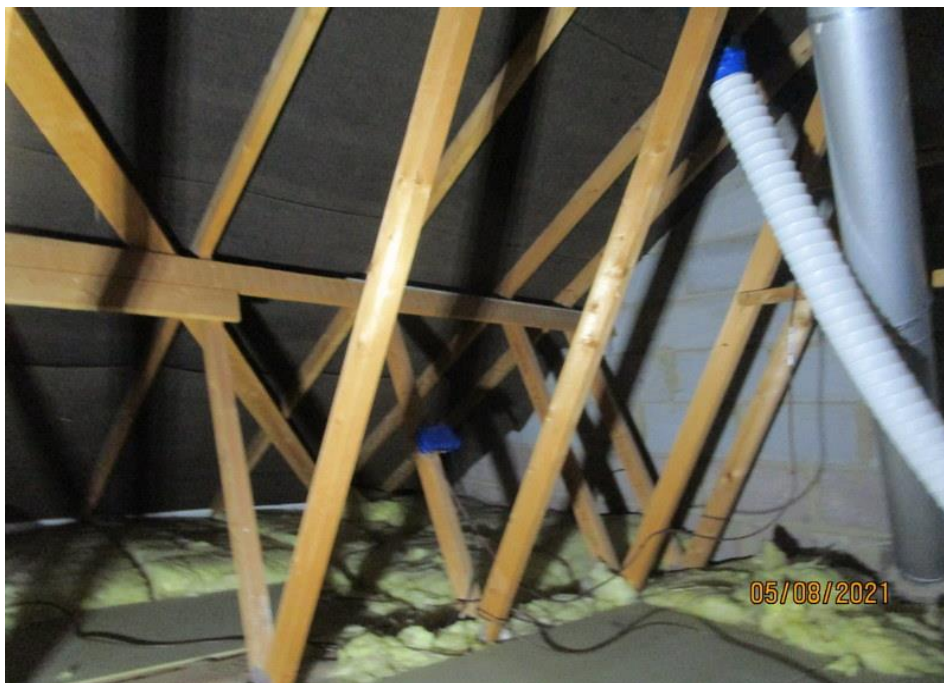
The roof is of timber-truss construction. Condition rating 1.

The roof trusses are satisfactory and fitted with cross-bracing to improve strength. No signs of distortion were noted.

Roof structure.

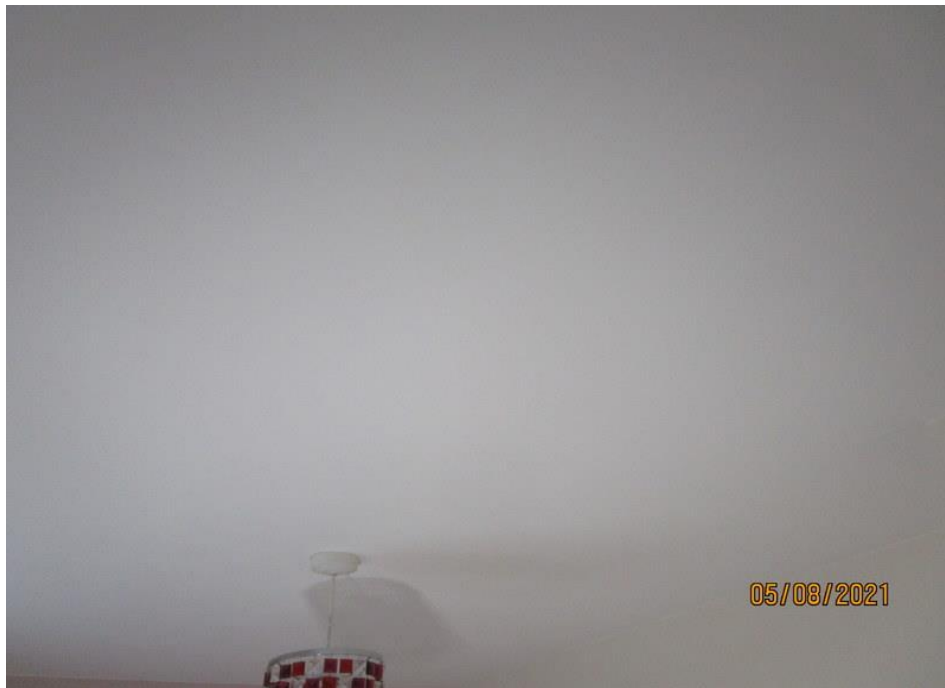
Ceilings are of plasterboard construction. Condition rating 1.

The plasterboard ceiling finishes are satisfactory and only slight hairline cracking was noted. These small cracks can be repaired before next redecoration.

Ceiling finishes are in satisfactory condition.

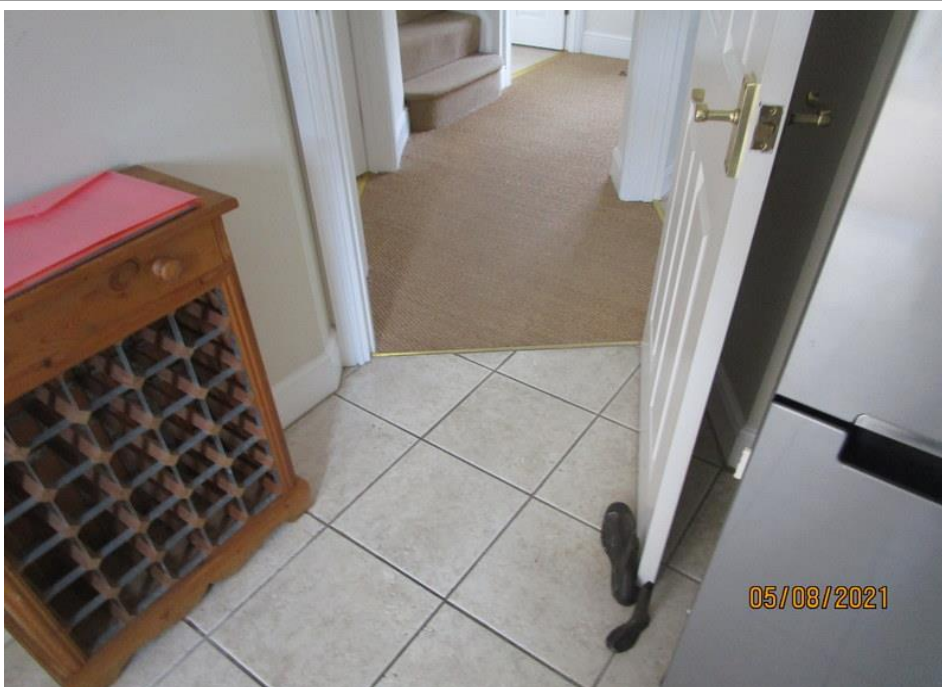
Floors are of suspended concrete (beam and block) construction at ground floor level and suspended timber construction with chipboard coverings at first floor level. Condition rating 1.

No signs of problems were noted in respect of the floors at ground floor level. There are a reasonable number of sub-floor air vents present in the lower walls.

Floors are of beam and block concrete construction at ground floor level.

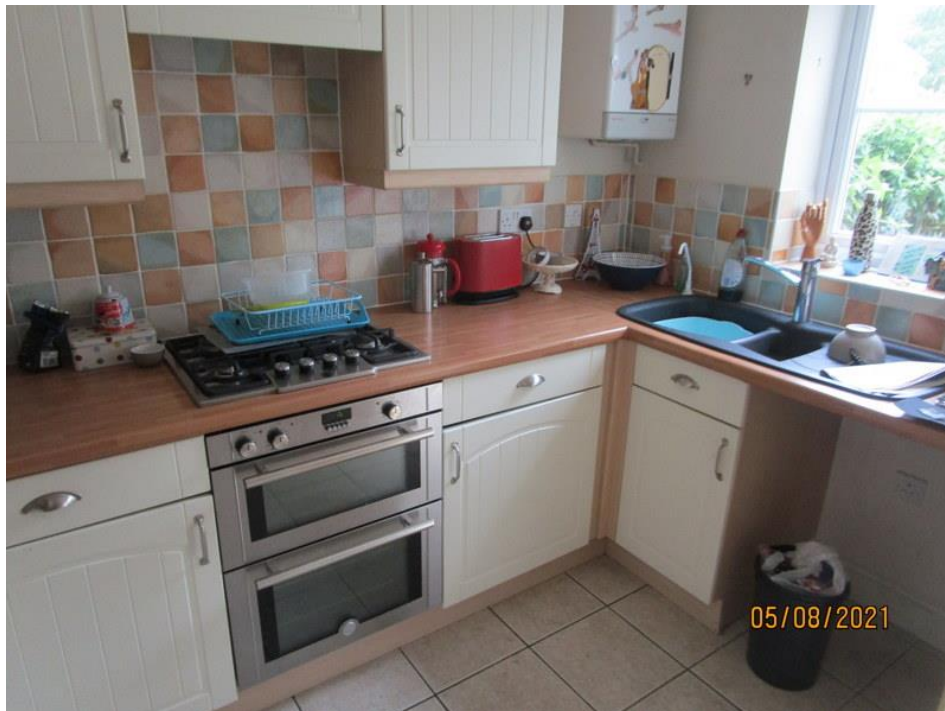
Kitchen fittings consist of a range of wall units and base units with work surfacing over. Condition rating 1.

The fittings are relatively modern and in adequate condition. There is a degree of wear and tear consistent with normal use.

Kitchen fittings showing gas hob.

Kitchen appliances were not tested. It is recommended that the gas hob be checked by a GSR registered contractor before use and then annually when the central heating boiler is serviced.

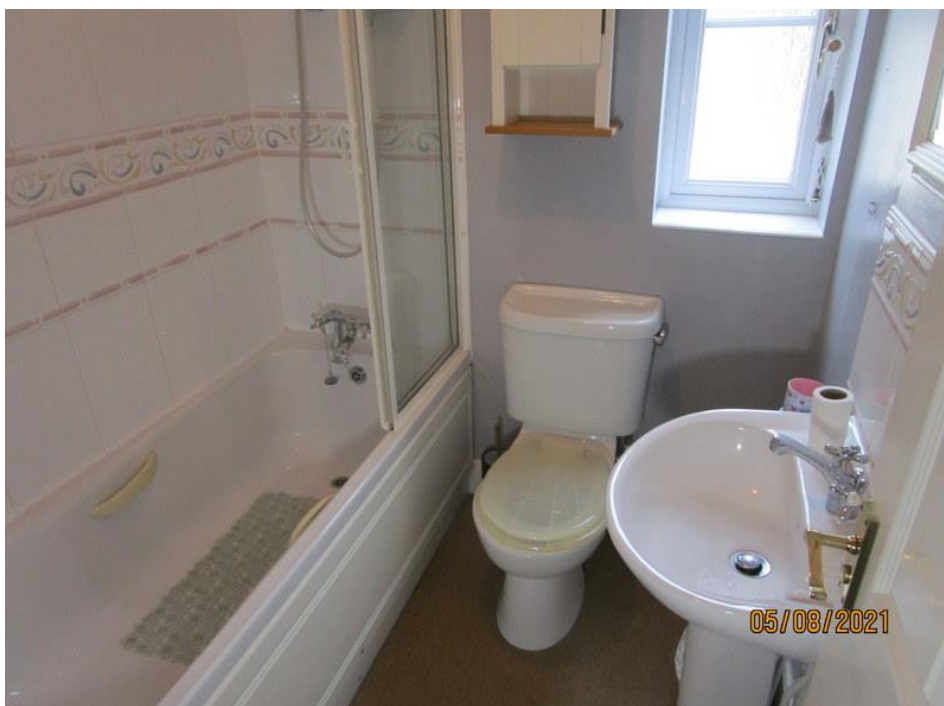
Sanitary fittings in the bathroom consist of a bath with electric shower over, WC and washbasin. There is a tiled shower cubicle with electric shower, WC and washbasin in the en-suite shower room and a separate WC and washbasin at ground floor level. Condition rating 2.

The sanitary fittings date from the time the property was built. Consequently, they are now of a slightly dated style and there is a degree of general wear and tear consistent with normal use.

Sanitary fittings in the bathroom.

Subject to undertaking maintenance in the short term, replacement could be delayed into the medium term.

It may be necessary to replace extractor fans in order to help avoid problems of condensation.

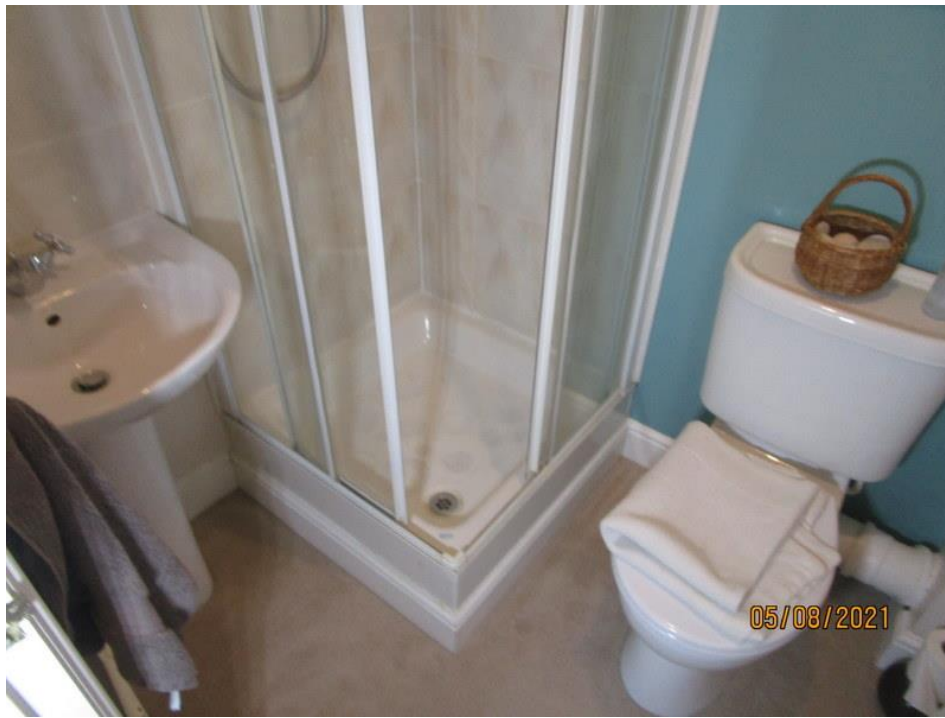
Sanitary fittings in the en-suite shower room.

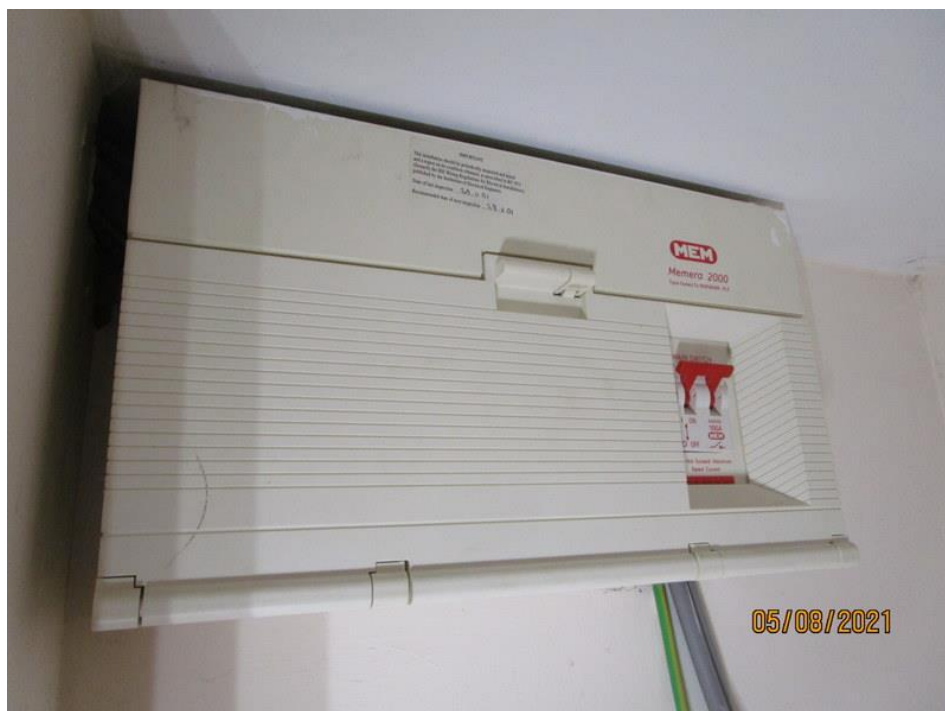
Mains electricity is connected with the meter and consumer unit being located under the stairs. Condition rating 3.

Electrical consumer unit beneath the stairs.

It is recommended that you instruct a qualified electrical contractor to test the system and provide further advice on any improvements required. You may wish to install extra power points and new light fittings to suit your own requirements. If checked and confirmed as satisfactory, this element can have a condition rating 1.

It is recommended that you install a more comprehensive fire detection and alarm system with a heat detector in the kitchen and linked smoke alarms in the hall and landing. Carbon monoxide alarms must be maintained in all rooms with gas appliances.

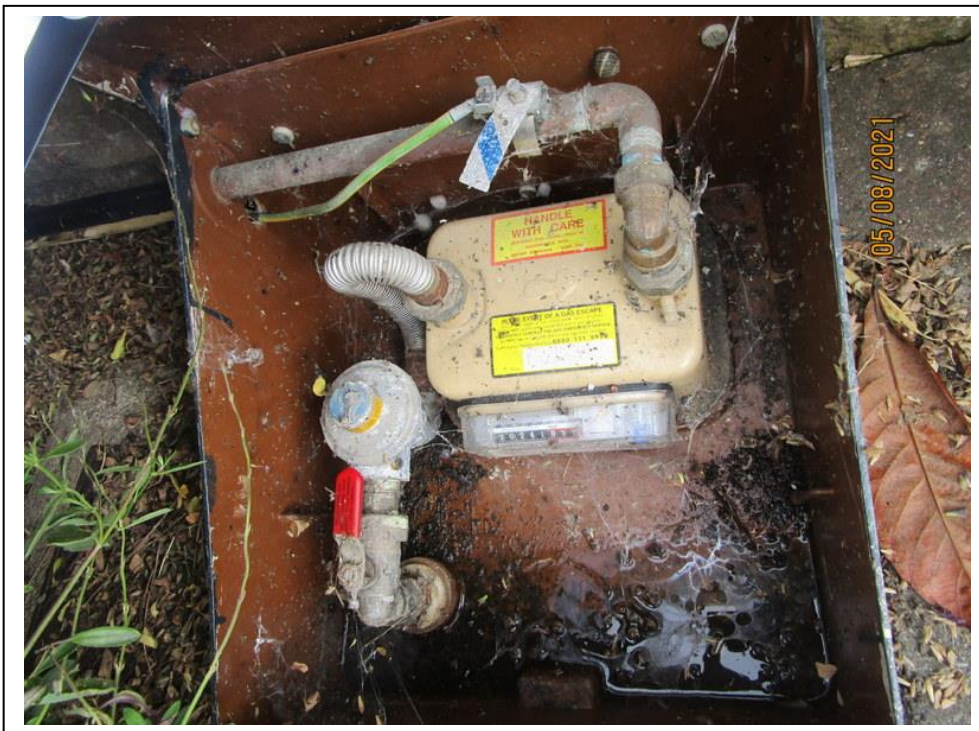
Mains gas is connected with the meter being located externally to the front at ground level. Condition rating 3.

The meter housing is broken and should be replaced.

The gas meter is located externally to the front.

It is recommended that you instruct a GSR registered contractor to check the gas installation each year when the central heating boiler is serviced. If checked and confirmed as satisfactory, this element can have a condition rating 1.

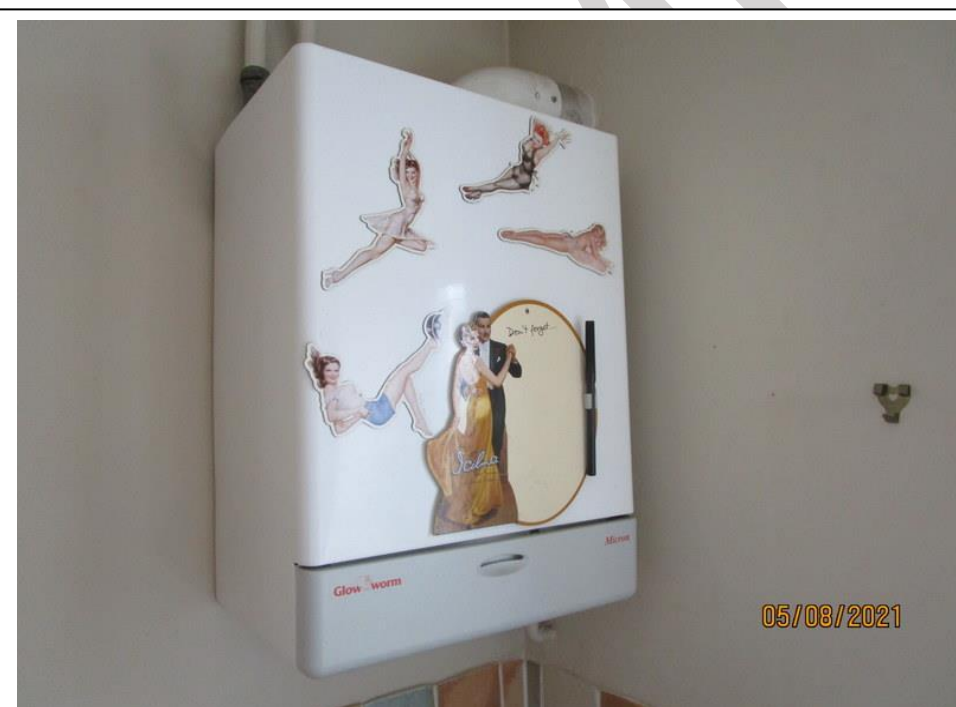
Space heating is provided by the 'Glow-worm Micron' boiler which is located in the kitchen. Condition rating 3.

The heating boiler is old and will need to be replaced in the medium term and sooner if faults develop.

The gas central heating boiler located in the kitchen.

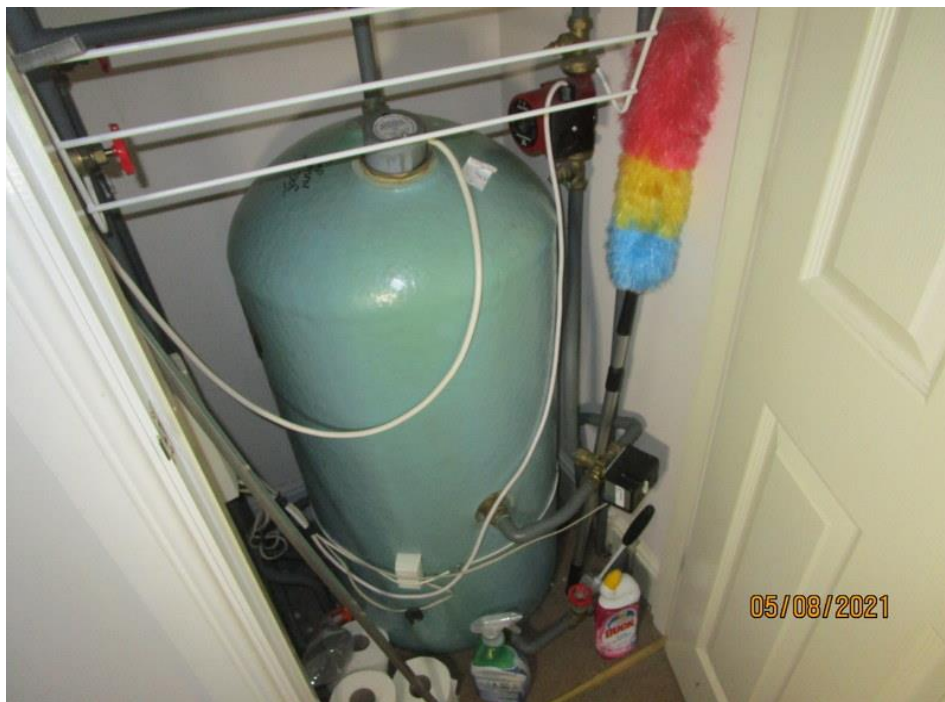
Water heating is provided primarily by the 'Glow-worm' boiler. There is a hot water tank in the landing airing cupboard. The tank has an electric immersion heater. Condition rating 3.

Hot water tank.

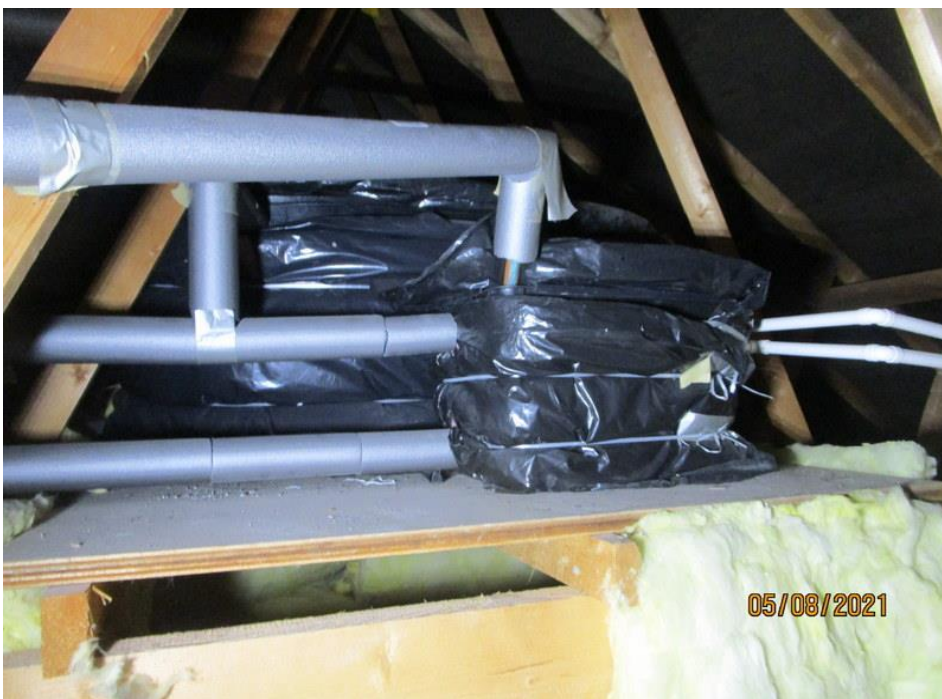
Cold water tanks in the loft.

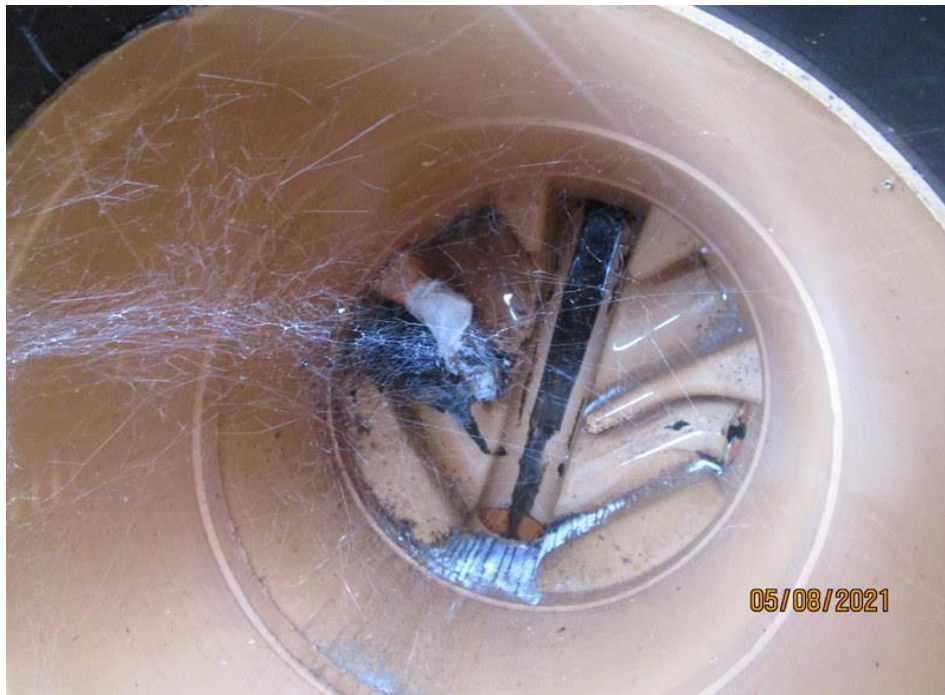
The property is connected to the mains drainage system. Condition rating 1.

The lids to two of the inspection chambers were lifted revealing drains of plastic construction. From this limited inspection, no signs of defects were noted.

Plastic drainage pipes to the front of the property.
