LEVEL 2

Your survey and valuation report

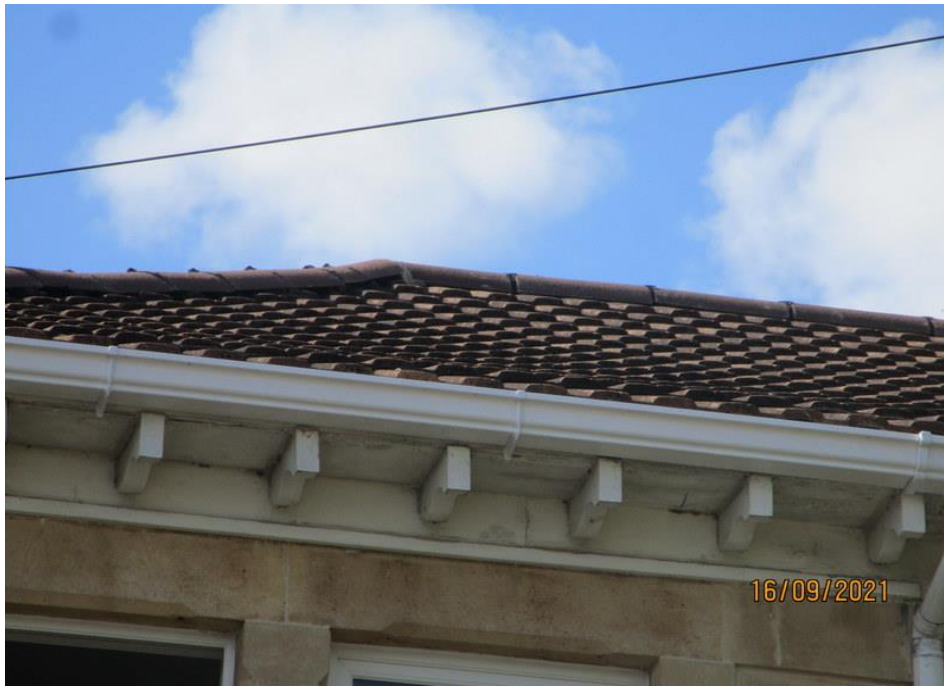
Externally this should include normal maintenance of the chimneys, roof coverings and rainwater fittings. These elements are in satisfactory condition at present. The roof structure would benefit from further strengthening as there are signs of weakness in relation to the timbers, possibly due to past re-covering using a heavy concrete tile.

There is a degree of distortion and sag affecting the front roof slope. Note modern plastic rainwater gutters and timber eaves joinery.

Recent re-covering of the roof would have been a good opportunity to carry out further works to strengthen and improve the roof frame. This has however not been undertaken and it is recommended that you plan and budget for some additional works to strengthen the roof. This will probably involve installation of new timber beams and struts to the front and left side parts of the roof and possible improvements to the work which has already been carried out to the rear. New binder timbers should be fitted to tie-in the feet of the rafters to the left side. Work of this type should be specified by a Structural Engineer and carried out with Building Regulation approval.

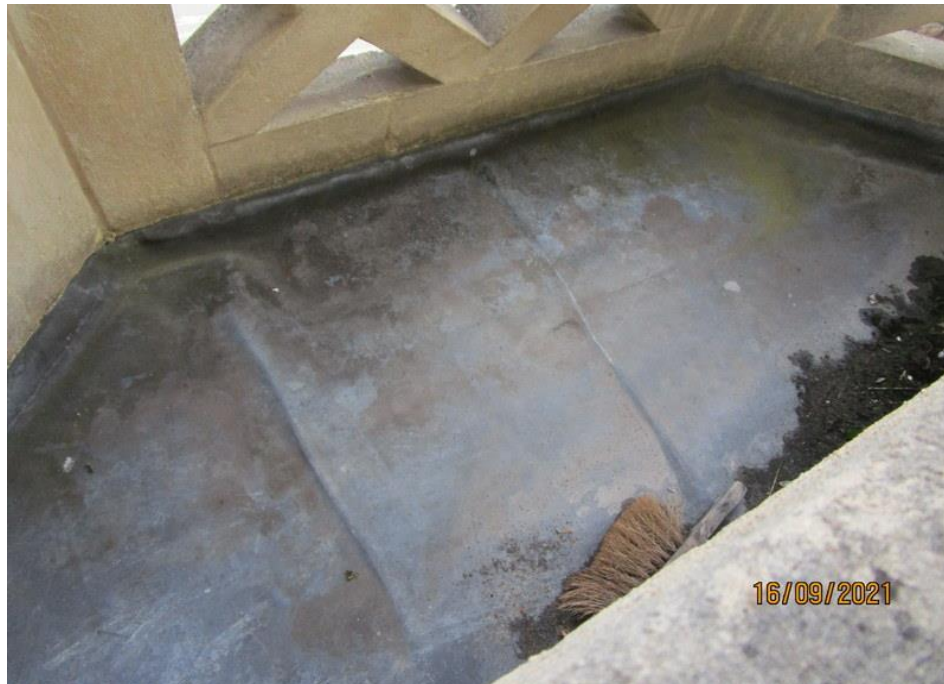
The small flat roof of the front bay has lead coverings externally. Wrinkles indicate thermal stress and splits are likely to occur resulting in leaks. The rainwater outlet is blocked and should be cleared as soon as possible. It is recommended that you budget for replacement of the lead coverings in the short or medium term.

Wrinkles in the lead sheet to the roof coverings of the front bay caused by thermal stress.

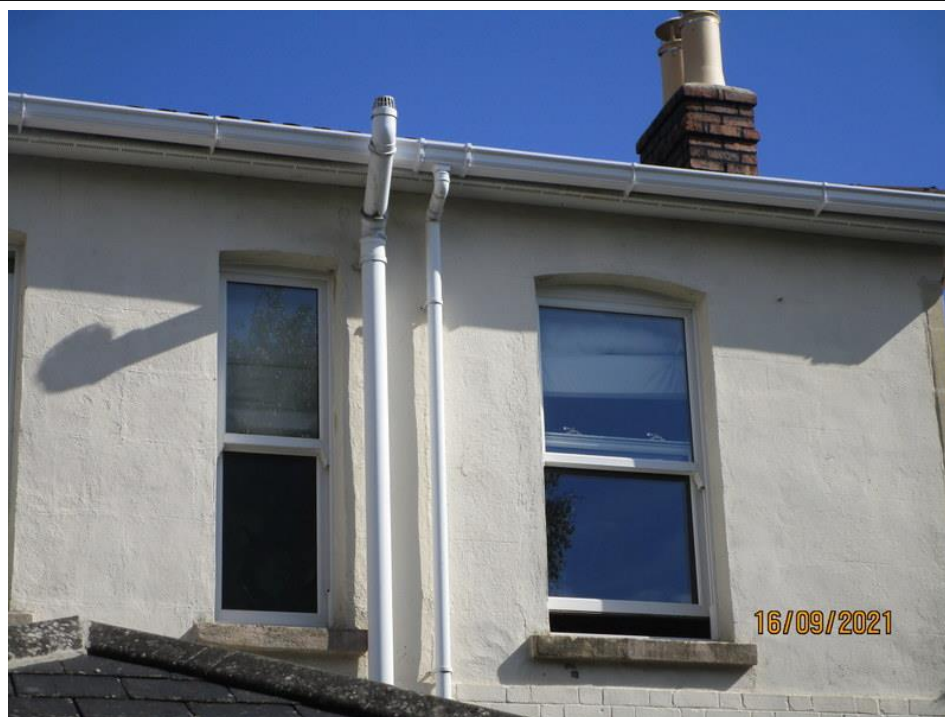
The render finishes to the main rear wall have been patch repaired in the past and areas of hollow render were detected. It is recommended that the render be removed, that the masonry beneath be repaired and that a new lime render be provided. Removal of the render may reveal cracks to the masonry beneath. Old / historic cracks can be stitch repaired using helical metal ties. You should obtain written quotations before purchase.

Rainwater fittings and render finishes to the upper rear wall.

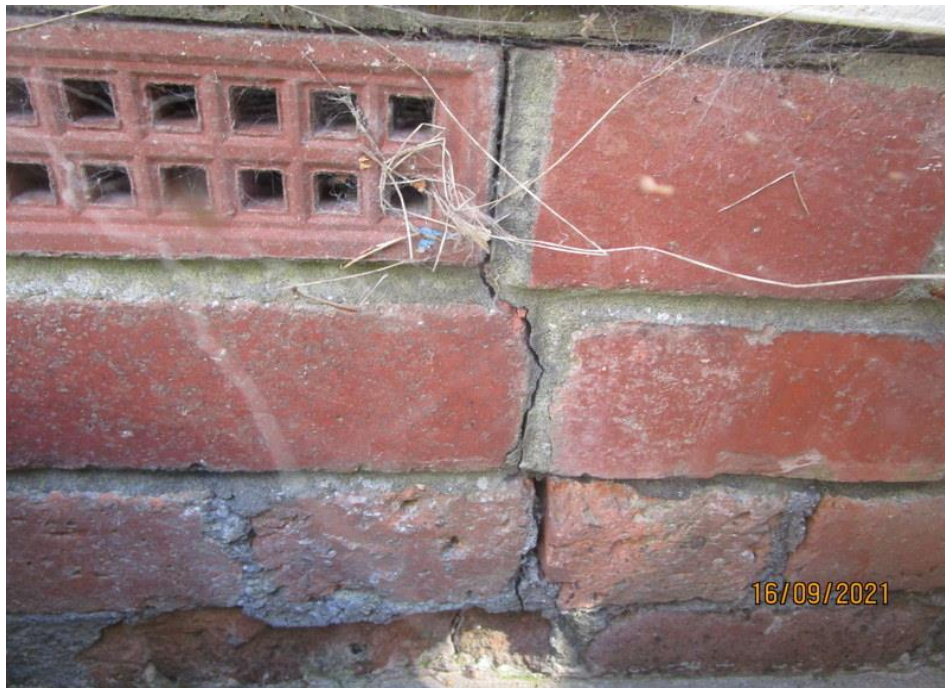
Cracking was noted around the front bay and around the left rear corner of the property. The cracks have been repaired and repointed in the past although they have reopened slightly and some of the internal cracking has occurred since last redecoration.

The cracks are probably the result of a combination of the factors mentioned above and due to the fact that the property will have been built with shallow foundations. Bay windows are often seen as a weak point in properties of this age. In the first instance, it is recommended that trees growing close by be removed and the cracks observed for further movement.

Cracking affecting the brickwork above ground level to the left rear.

If any significant cracks appear, you must obtain further advice from a qualified Structural Engineer who will be able to monitor the cracks and investigate foundation construction and ground conditions. The Structural Engineer will be able to advise on repair options if necessary. It is often recommended that bay windows be underpinned and strengthened with the installation of helical metal ties. Underpinning of the main walls would likely be considered as a last resort but is not uncommon where properties have been built on filled ground.

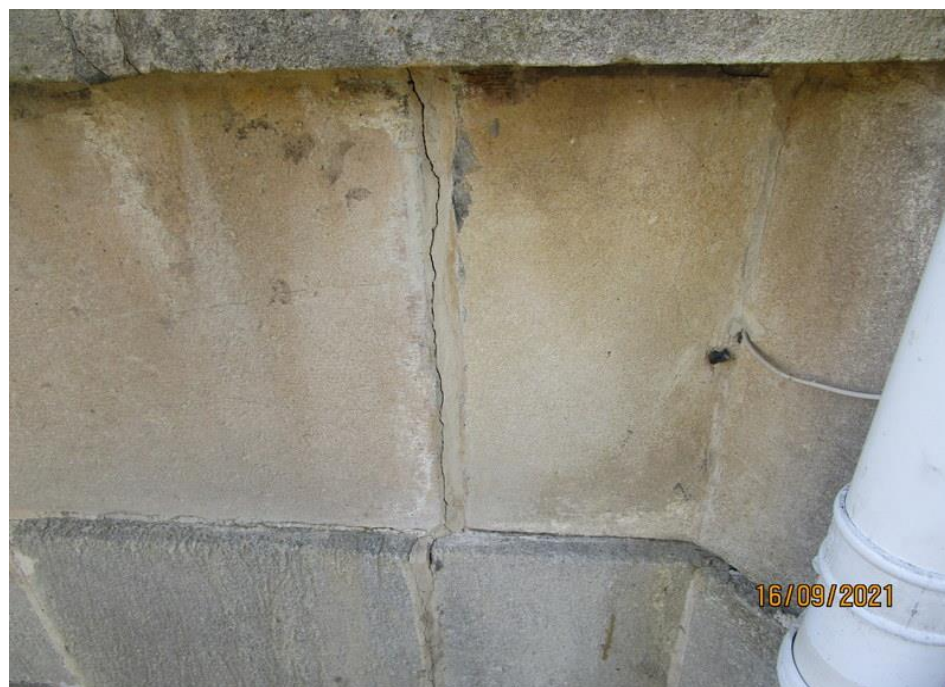
Cracks to the stonework around the front bay have been recently repaired but have reopened slightly.

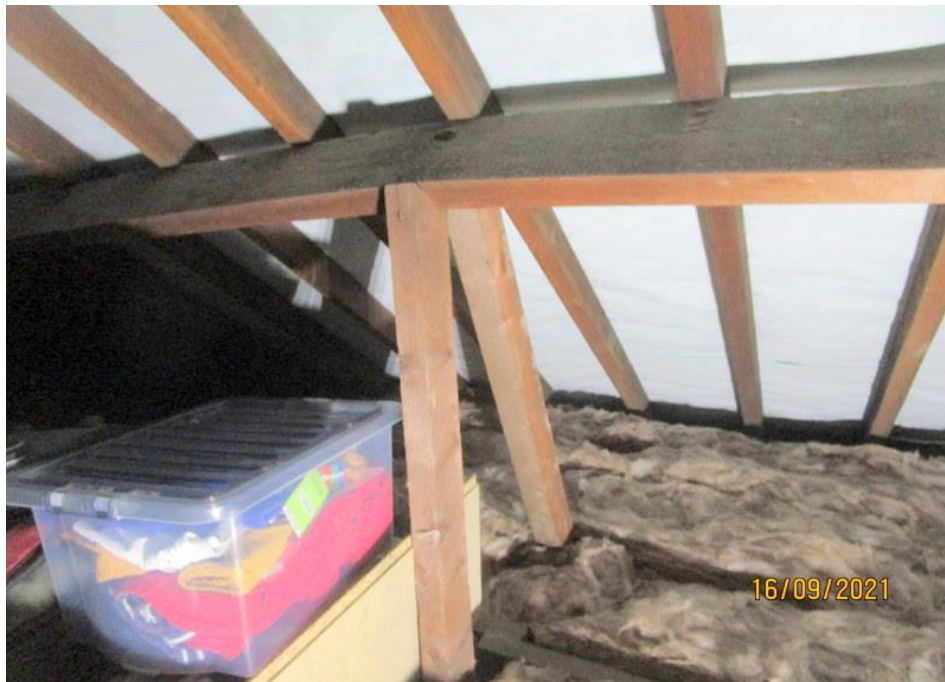
Rafters and purlin to the left side of the main property. Note distortion affecting the purlin timber above the strut.

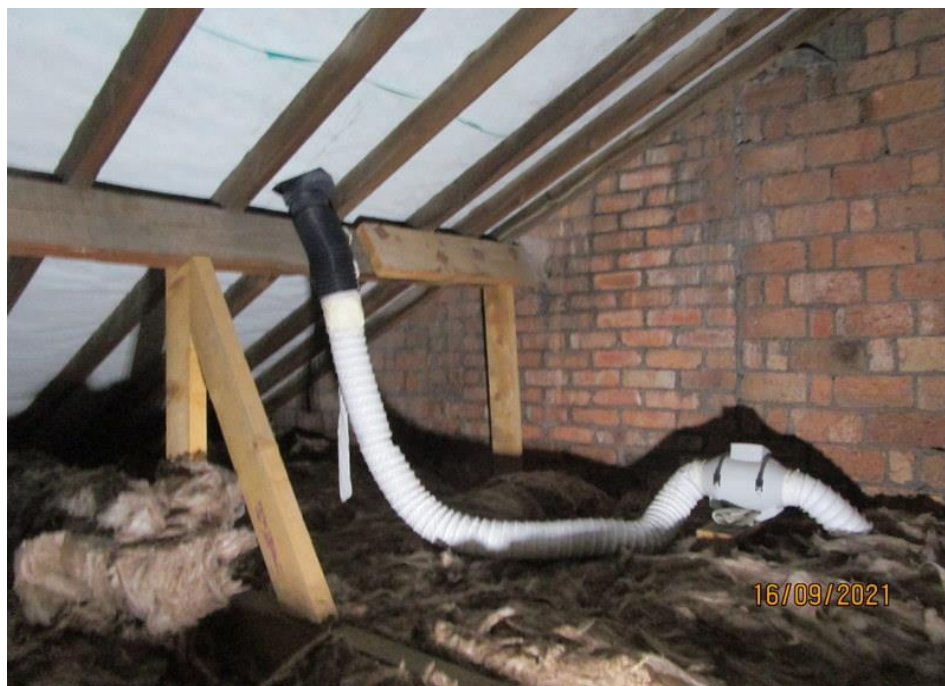
The rear part of the roof has been strengthened with the installation of extra struts and the purlin bearing has been improved.

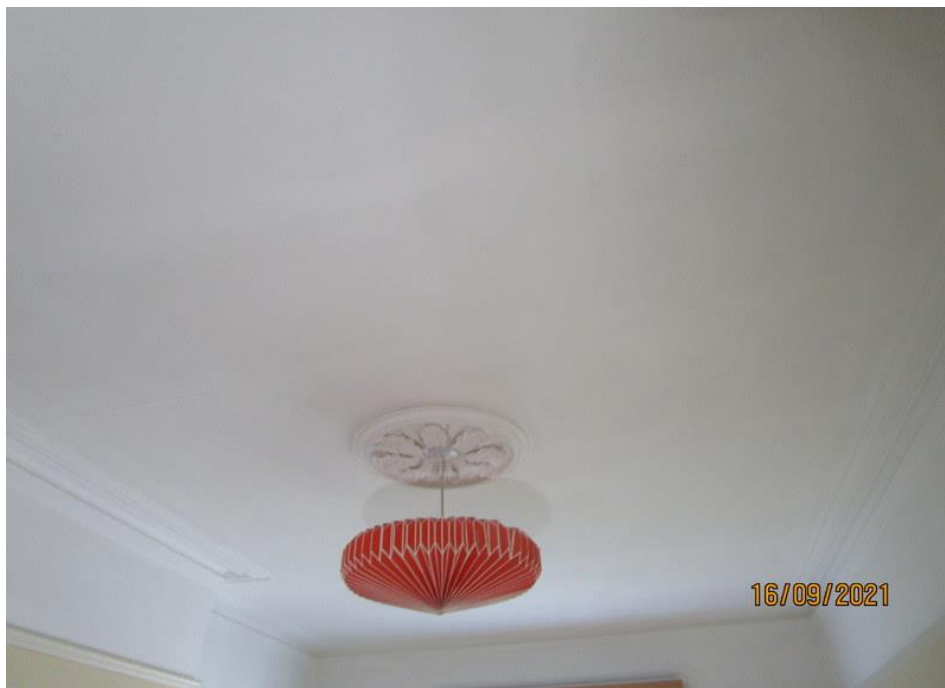
Lath and plaster ceiling finishes tend to have a limited life expectancy as they are prone to cracking and potential collapse. Most of the ceiling finishes appear to be in adequate condition although several ceilings, including those in the living rooms and bedroom one, have papered finishes. The finish to the ceiling in the dining room is relatively poor. Removal of papered finishes would inevitably reveal or cause damage necessitating either repair or replacement of the lath and plaster.

Ceilings are of both plasterboard and lath and plaster construction.

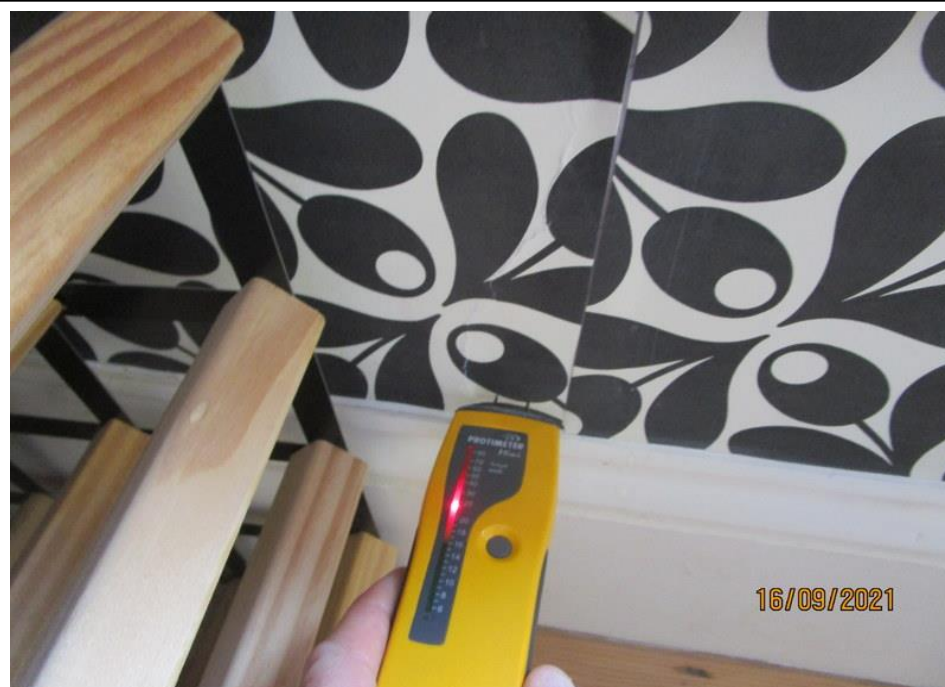
The property was regularly tested using an electronic moisture meter and for the most part, no signs of dampness were noted in the lower walls. Localised raised moisture meter readings were recorded to the rear of the dining room and this could be connected with deteriorating render finishes externally. The rear parts of the property are most exposed to the prevailing weather. See Section D4 and Section I.

Localised raised moisture meter readings were recorded to the rear wall of the dining room.

- Provision of improved sub-floor ventilation.
- Careful maintenance of external elements including render wall finishes to the rear.
- Reinstatement of lime plaster finishes inside.
- Provision of consistent heating and ventilation to help reduce condensation which can be a contributory cause of dampness in the walls.

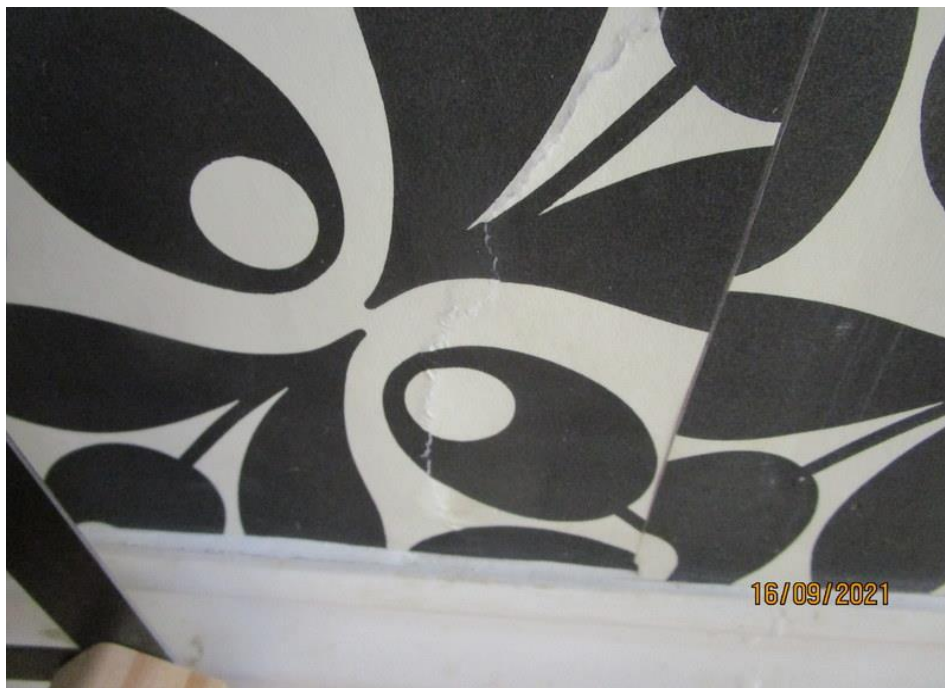
Slight cracking was noted to the walls in some areas including walls in the sitting room and dining room. It is highly likely that plaster and papered finishes conceal cracking to the masonry beneath. As described in Section D4 above, the property has been affected by a degree of movement in the past as a result of shallow foundations and changes in moisture content of the soil. There are trees growing close by to the left rear and vibrations caused by heavy road traffic close by could also result in cracking. Some of the cracks have appeared since the property was last redecorated. See Section D4 and Section I.

Evidence of cracking to the walls beneath plaster and paper finishes.

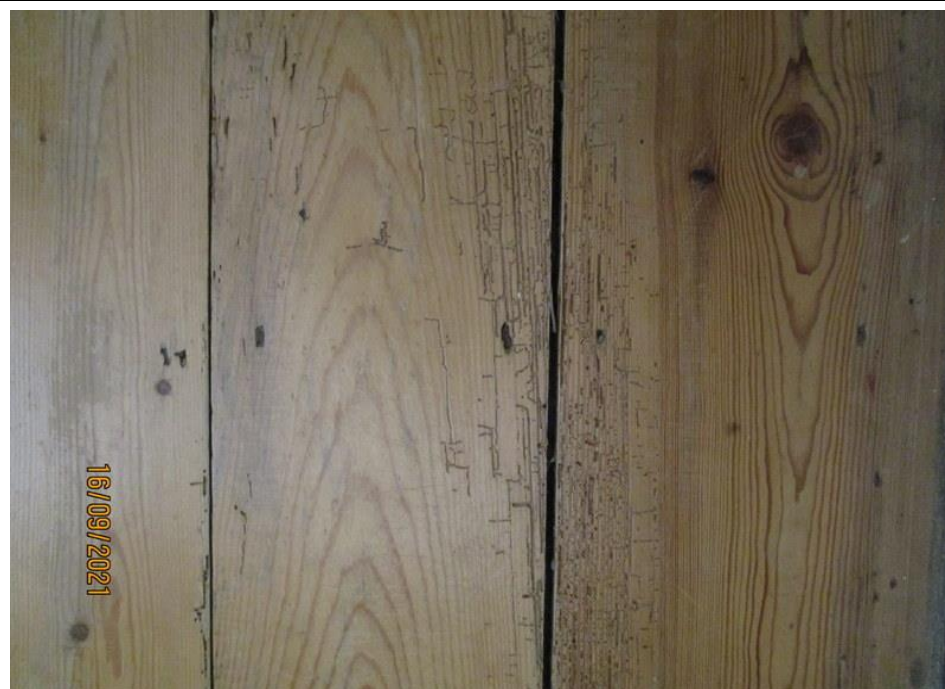
As a precautionary measure, concealed floor timber should be checked for signs of wood-beetle activity and treated if necessary. There are signs of wood-beetle activity affecting the floorboards where visible in the living rooms. Provision of improved sub-floor ventilation is recommended to promote dry conditions in the sub-floor void and to help protect floor timbers.

Historic wood-beetle activity affecting floorboards.
