LEVEL 3

Your survey report

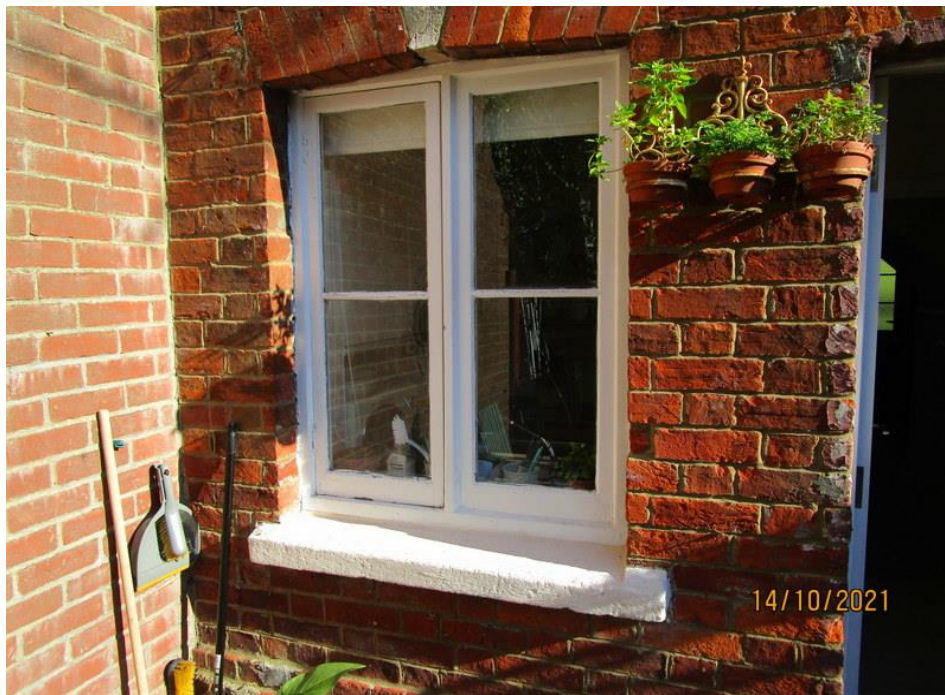
The windows to the rear of the property are old and showing signs of deterioration. Patch and filler repairs have been carried out in the past and there is damage to the putty seals. Condition rating 2.

Older window to the rear of the kitchen.

It is recommended that you plan for replacement of the rear windows in the medium term.

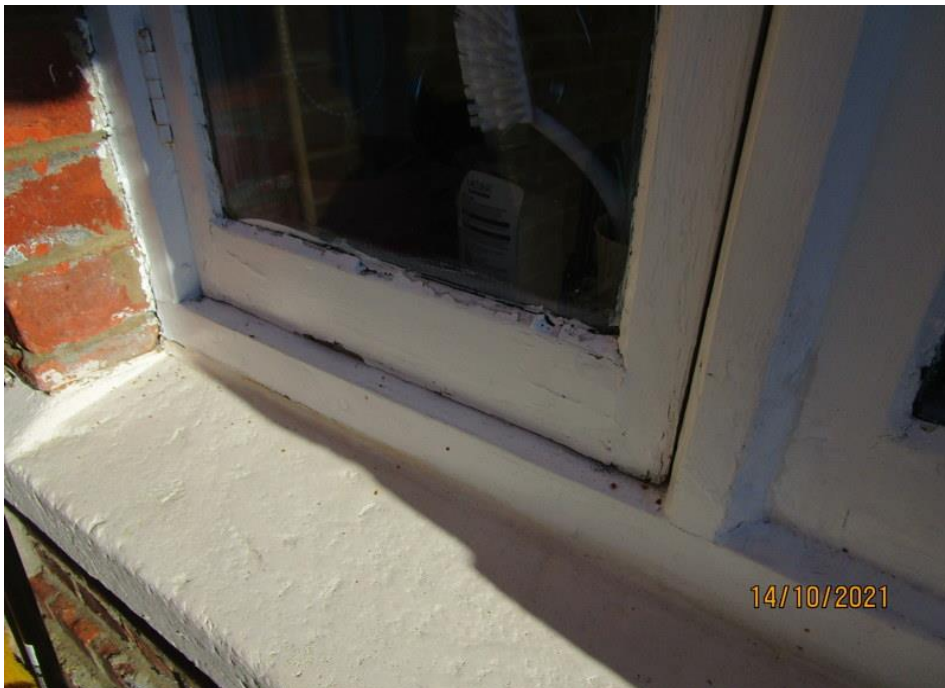
Deterioration affecting joinery and putty seals.

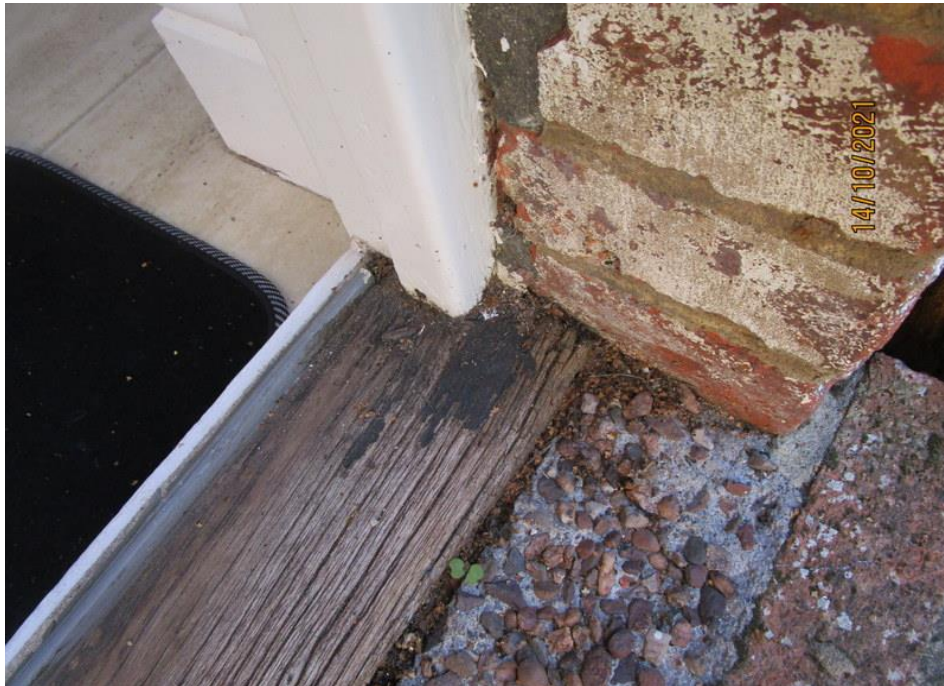
The frame and sill to the door are older and signs of deterioration were noted. The sill and frame will need to be replaced in the medium term.

Deterioration affecting the rear door sill.

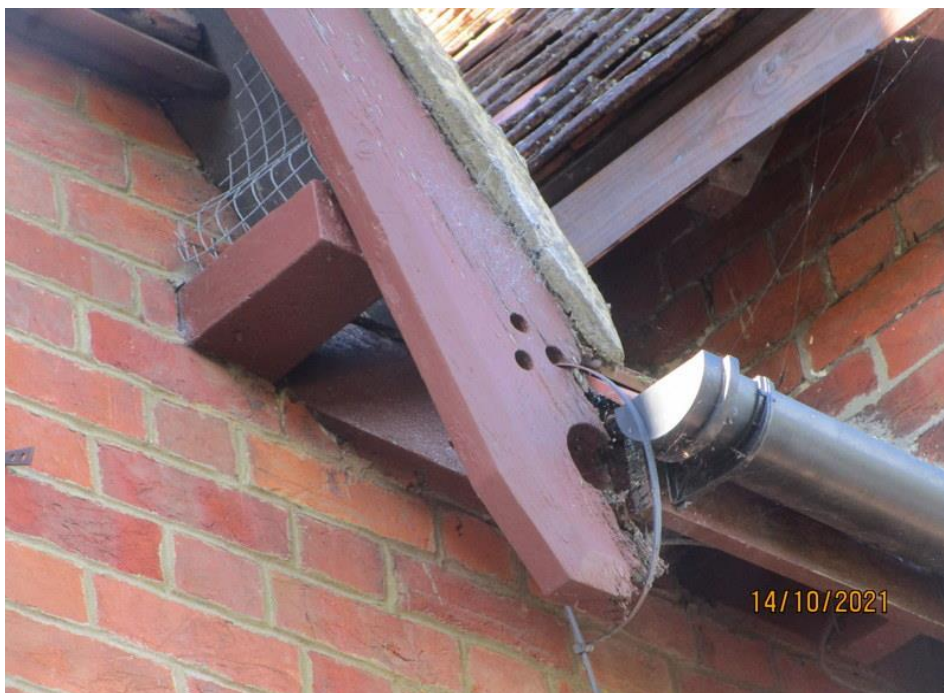
Certain works of maintenance and improvement will be required in respect of joinery at eaves level, particularly in respect of damaged timbers to the front. General maintenance will be required in respect of the dormer window to the rear of the property.

Maintenance will be required in respect of joinery at roof level.

- Overhaul joinery at eaves level and around the rear dormer.
- Repair the front porch.
- Maintain internal wall and ceiling finishes. Be aware that the lower walls will become increasingly affected by dampness and measures should be taken to reduce long-term risks.

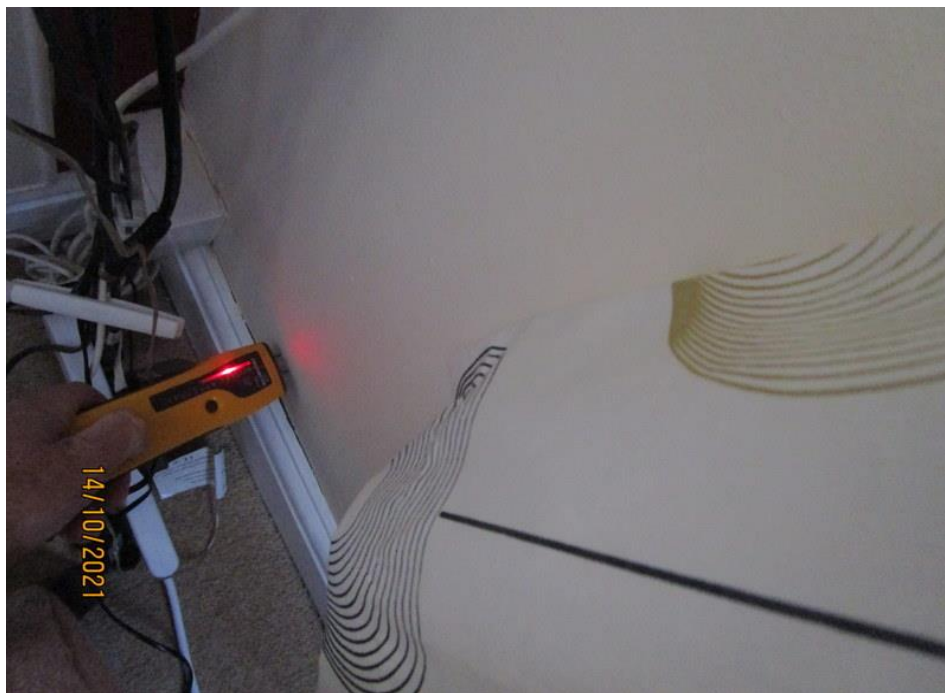
You should be aware that all the lower walls of the property will be vulnerable to dampness and raised moisture meter readings were recorded in a number of areas at skirting level; visible signs of dampness will become more evident in the future and possibly when the house is empty. There are some works which should be carried out to reduce the risk of long-term dampness as described further below.

Raised moisture meter readings were recorded in a number of areas at ground floor level.

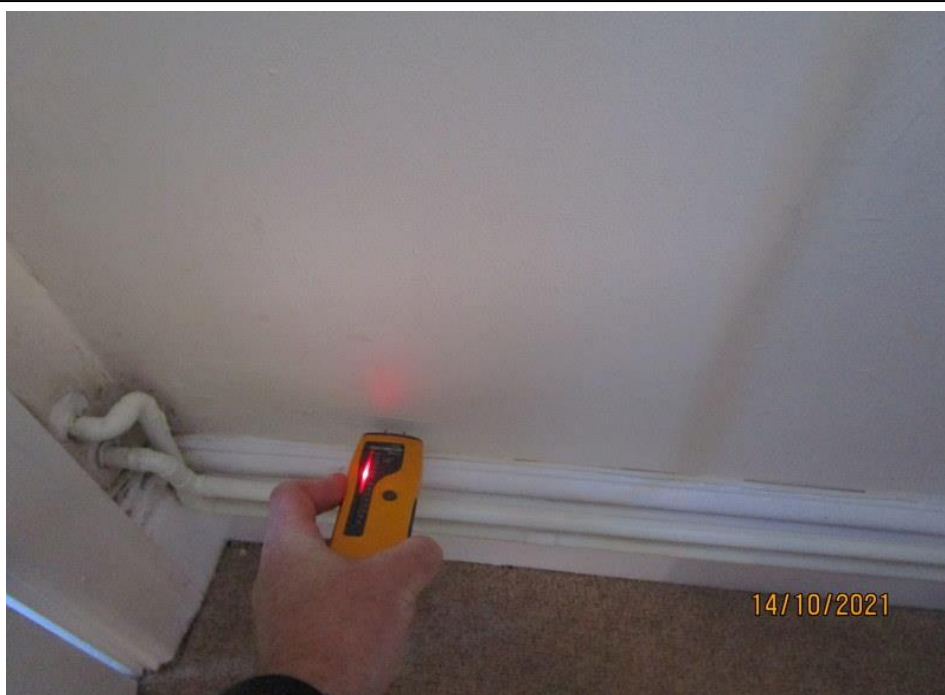
Raised moisture meter readings to the left side wall of the sitting room.

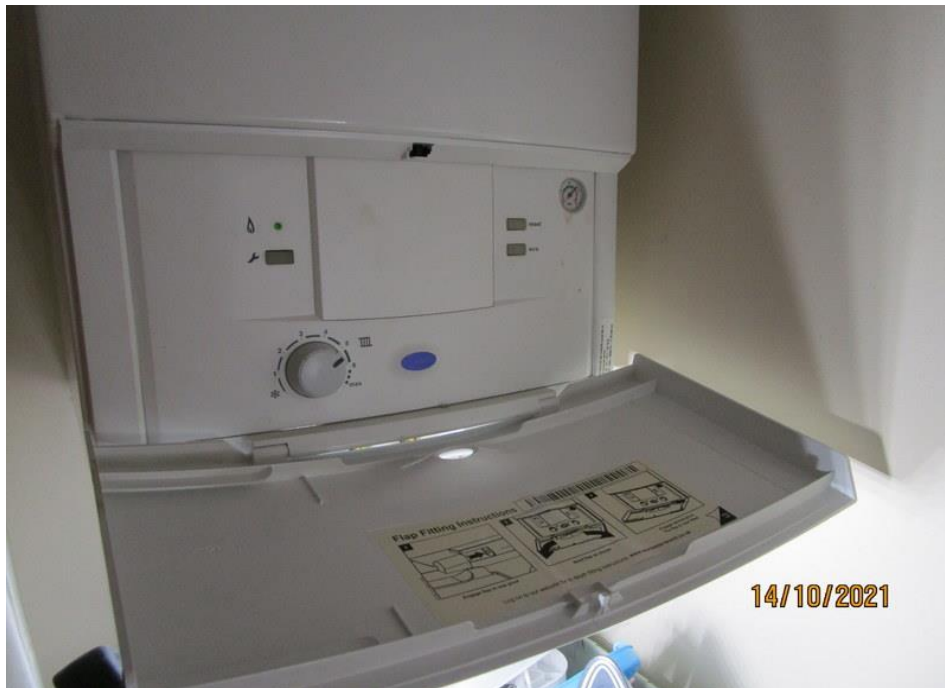
The central heating boiler is of a condensing type fitted in 2013.

- Arrange for regular tests of the electrical installation and annual servicing of the central heating boiler. The heating boiler will need to be replaced in the long term and sooner if serious faults develop.
- Replace boundary fences where necessary.

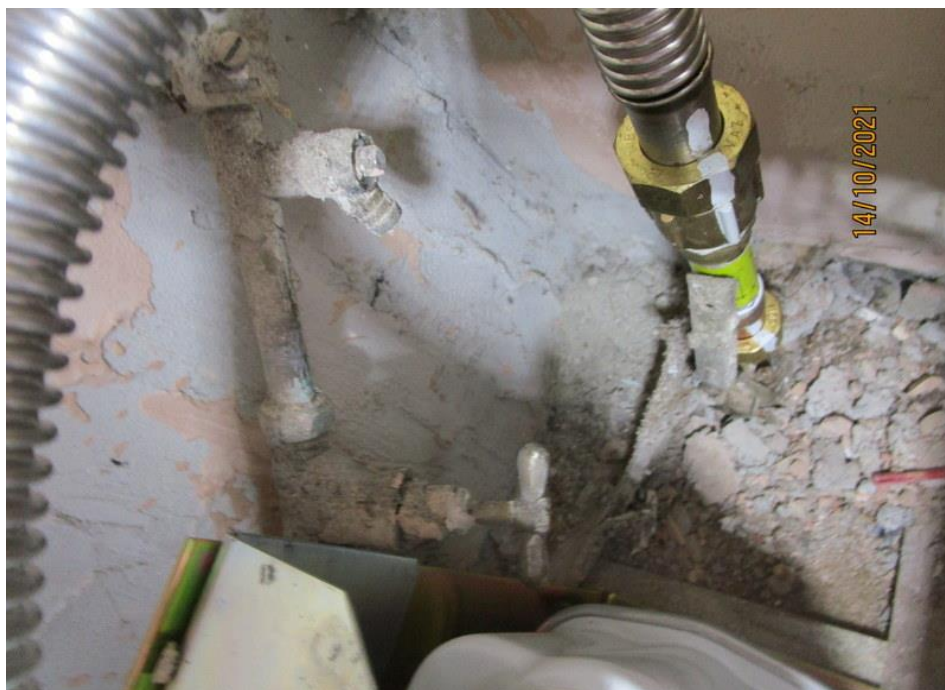
No signs of problems were noted in respect of the drainage pipes which run from left to right to the rear. Water pipes leading into the property were mostly hidden from view however pipework around the internal stop-tap to the front right of the sitting room is old and the need for replacement of the incoming water pipe cannot be ruled out.

Gas pipes and water stop-tap.

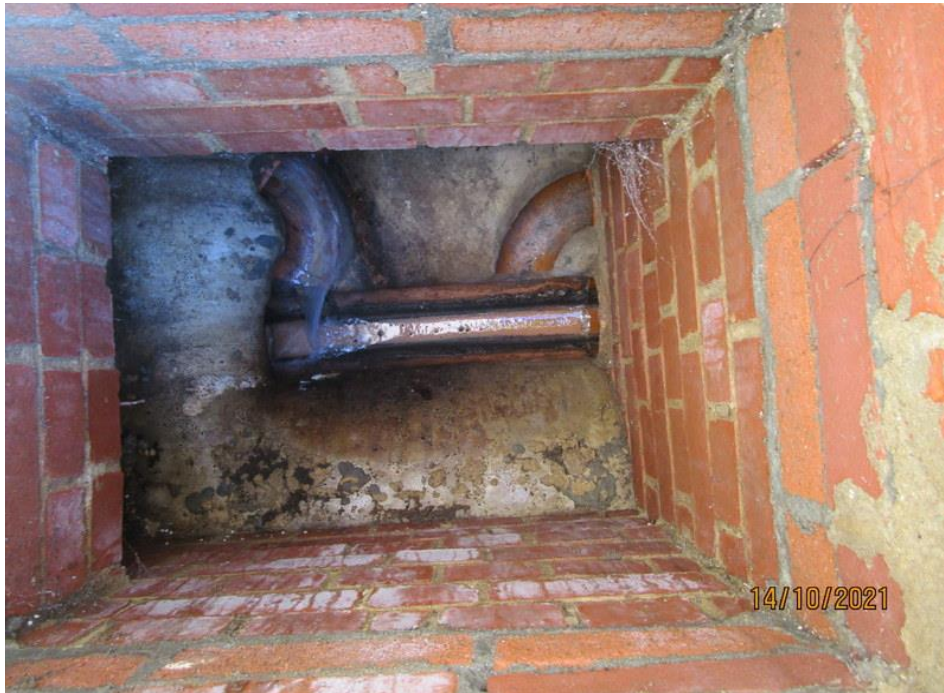
Water was found to flow cleanly through the drains and there were no signs of problems either with the pipework, inspection chamber or lid.

Clay drainage pipes to the rear of the property.
